**Flood Control Project Maintenance
Levee Inspections**
LMA District Cover Sheet
Spring 2019 Levee Inspection Results

Reclamation District No. 0341 Sherman Island

Spring 2019 Levee Inspection Results

Waterway			Bank	Unit Miles
Unit No. 01 Threemile Slough			Right	3.36
	Spring (March - May)	Summer (June - August)	(September - November) Fall	Winter (December - February)
Unit Maintenance Rating (Fall Only)				
Date of Inspection	3/28/2019 - 3/28/2019			
DWR Inspector	David Julian			
Accompanied By	Wade Wylie DWR

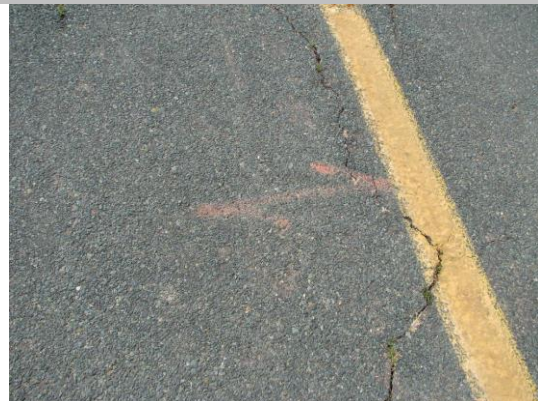
Photo 1 of 3 : UCIP_SP_2019_52253_37647.jpg

Comment Code					
Inspector Comment					
FS_ID:52253 DS_ID:24110 EP_NO: 6297 Repair Type: Non-Urgent Crossing Status: Found UCIP Comments: 07/06/2016 According to LMA Superintendent, Joel McElroy, the posts located on WS are markers indicating line. Line comes from Twitchel Island to Sherman Island. (DWR UCIP - O. Magana) 05/05/2009 Markers Missing. Underground alert service (USA) markings visible on road surface. No markers found to confirm crossing is still in use--need to contact owner to determine status of crossing. (DWR UCIP - O. Magana) FIELD_STRUCT_DESC: 3-inch electrical transmission cable of unknown material through the levee, 3.5 feet below the crown. Location marker located on the waterside (WS) shoulder--no marker found in 2013. Pole located on the landside (LS). Rock revetment along the on WS slope. (Permit No. 6297, 1969 - Pacific Gas and Electric Company [PG&E]) [Additional Reference(s): DWR Levee Log, 1992. LMA encroachment station (STA) reference based on Map of Evacuation Route, Reclamation District 341 Sherman Island by Wagner Bonsignore Consulting Civil Engineers, A Corporation dated July 2012, STA 148+00] FS Date: 5/5/2009

Underground Service Alert (USA) markings on road surface indicating line is still present.

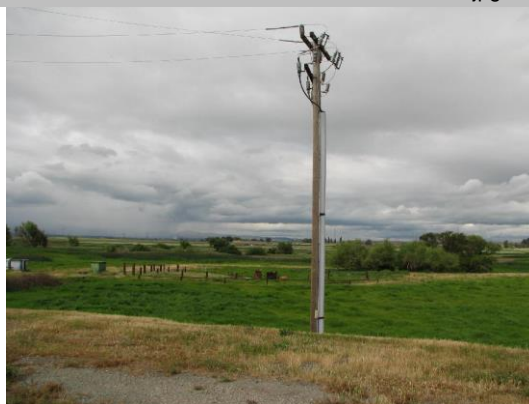
Photo 3 of 3 : UCIP_SP_2019_52253_37645.jpg

Power pole located on LS aligns with crossing.

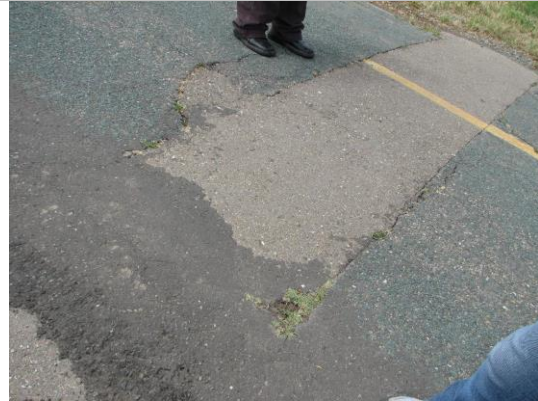
Photo 1 of 3 : UCIP_SP_2019_52254_37654.jpg

FS_ID:52254
DS_ID:24111
EP_NO: 1477
Repair Type: Non-Urgent
Crossing Status: Found
UCIP Comments: 07/06/2016 According to LMA Superintendent, Joel McElroy, the LS pipe section was replaced in about 2005 under the Three Mile Slough Project. No work was completed on crown or WS. (DWR UCIP - O. Magana)
05/05/2009 Dense vegetation limits the inspector's visibility to identify signs of pipe failure (leaks) along the slopes. Recommend removing vegetation along pipe alignment to conduct proper inspection of structure and appurtenances. (DWR UCIP - O. Magana)
FIELD_STRUCT_DESC: 10-inch steel irrigation siphon pipe through the levee, 1.8 feet below the crown. 10-inch pipe is encased in 12-inch corrugated metal conduit under crown. Pump is located on landside (LS). Air vent and metal distribution box with gate are located on the LS. Rock revetment placed along the waterside (WS) slope. A 30-foot section of pipe under the crown was replaced and encased in corrugated metal pipe (CMP) under unknown permit. (10-inch pipe authorized under Permit No. 1477, 1950 - L. J. Anderson) [Additional Reference(s): DWR Levee Log, 1992. USACE Sacramento O&M Manual Unit No. 101, February 1962, (HLM 0.50). LMA encroachment station (STA) reference based on Map of Evacuation Route, Reclamation District 341 Sherman Island by Wagner Bonsignore Consulting Civil Engineers, A Corporation dated July 2012, STA 149+00]

Cut along pipe alignment--unknown repair or maintenance date.

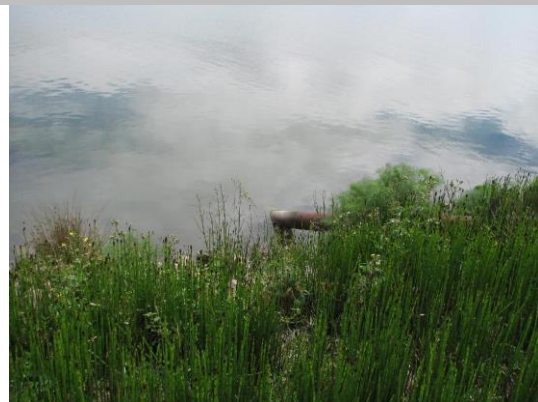
Photo 2 of 3 : UCIP_SP_2019_52254_37658.jpg

Pipe visible from WS.

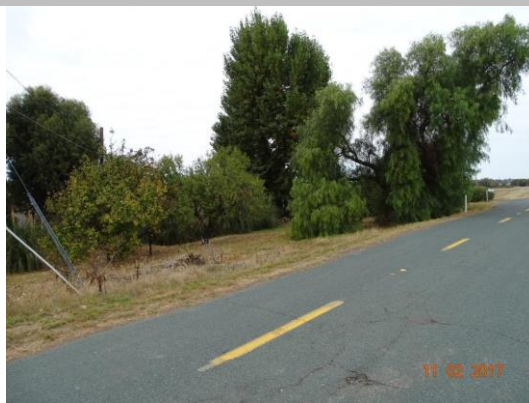
Photo 1 of 1 : SP_2019_RD0341_167_20_20190311_00001.jpg

View of large willow tree and pampas grass on the landside slope and toe.

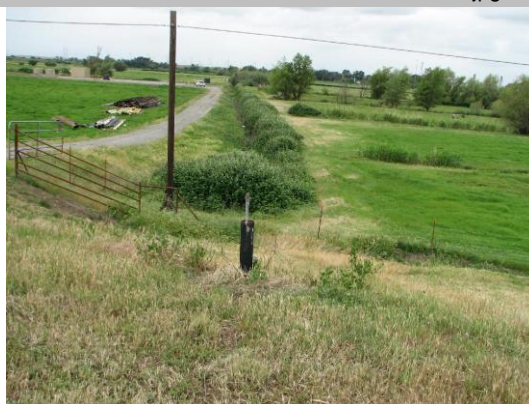
Photo 2 of 3 : UCIP_SP_2019_52255_37663.jpg

Comment Code						
Inspector Comment						
FS_ID:52255 DS_ID:24113 EP_NO: 11095 Repair Type: Non-Urgent Crossing Status: Found UCIP Comments: 07/06/2016 According to LMA Superintendent, Joel McElroy, this pipe is an irrigation siphon pipe and not a drainage pipe. Primer stem and primer is located on the LS near the berry shrubs. (DWR UCIP - O. Magana) 05/05/2009 Dense vegetation limits the inspector's visibility to identify signs of pipe failure (leaks) along the slope. Recommend removing vegetation along pipe alignment to conduct proper inspection of structure and appurtenances. (DWR UCIP - O. Magana) FIELD_STRUCT_DESC: 18-inch steel irrigation siphon pipe sleeved through 24-inch pipe through the levee, 4 feet below the crown. Primer stem and primer located on the landside (LS). Pipe exposed on the waterside (WS) slope. (18-inch pipe authorized under Automatic Board Order (ABO) issued as Permit No. 11095, 1975 - A. M. Cabral). [Additional Reference(s): DWR Levee Log, 1992. LMA encroachment station (STA) reference based on Map of Evacuation Route, Reclamation District 341 Sherman Island by Wagner Bonsignore Consulting Civil Engineers, A Corporation dated July 2012, STA 118+00] FS Date: 5/5/2009

View of LS--visible standup pipe with primer stem is located on the LS slope.

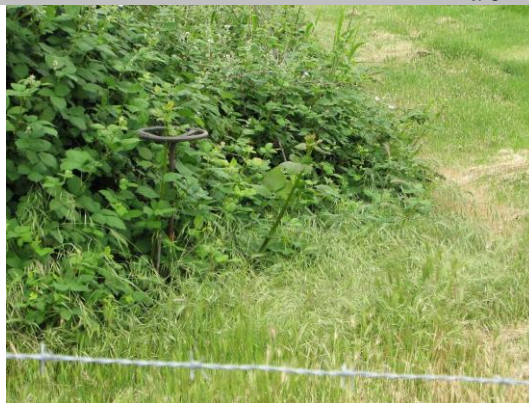
Photo 3 of 3 : UCIP_SP_2019_52255_37662.jpg

Gate located past the fence area near LS toe.

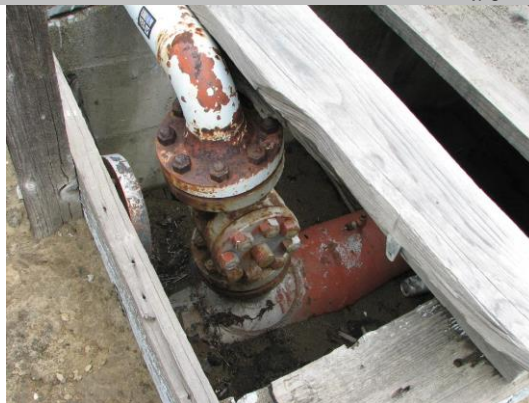
Photo 3 of 3 : UCIP_SP_2019_52256_37674.jpg

View of pipe inside concrete box located on LS.

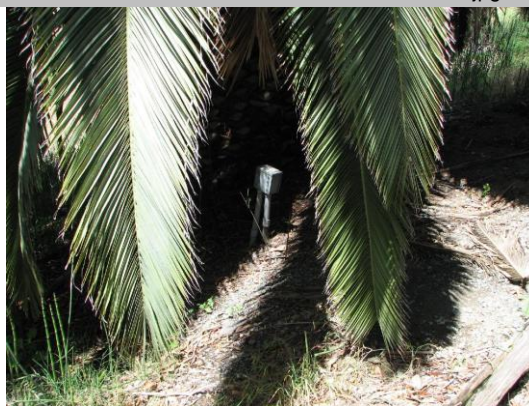
Photo 2 of 3 : UCIP_SP_2019_52258_37704.jpg

Comment Code					
Inspector Comment					
FS_ID:52258 DS_ID:24116 EP_NO: 11103 Repair Type: Non-Urgent Crossing Status: Found UCIP Comments: 05/05/2009 Unable to determine if crossing is the same as permitted under permit no. 11103. Need to contact owner and determine status of crossing under permit no. 11103. Believe steel conduit is exposed on landward side. (DWR UCIP - O. Magana) FIELD_STRUCT_DESC: 1.5-inch iron water pipe and 3.5-inch electrical steel conduit through the levee, both 3 feet below the crown. Pressure system and service pole located on the landside (LS) slope. Fishing resort located on the waterside (WS). (1.5-inch pipe authorized under Automatic Board Order (ABO) issued as Permit No. 11103, 1975 - Western Water Ways, Inc.; 3.5-inch not listed in Permit No. 11103) [Additional Reference(s): DWR Levee Log, 1992. LMA encroachment station (STA) reference based on Map of Evacuation Route, Reclamation District 341 Sherman Island by Wagner Bonsignore Consulting Civil Engineers, A Corporation dated July 2012, STA 71+00] FS Date: 5/5/2009

Power connection on WS no other appurtenances found.

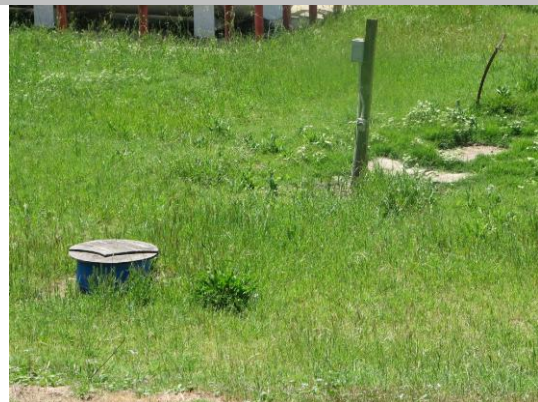
Photo 2 of 3 : UCIP_SP_2019_52259_37711.jpg

Comment Code						
Inspector Comment						
FS_ID:52259 DS_ID:24117 EP_NO: 5427 Repair Type: Non-Urgent Crossing Status: Indicator Found UCIP Comments: 07/06/2016 According to LMA Superintendent, Joel McElroy, the features on the LS include sump pump inside well and drain leach field. The septic line pumps from WS to LS and deposit water in hole. (DWR UCIP - O. Magana) 05/05/2009 Unable to find pipe or sump pump. Indicators found on landward side include potential septic tank and observation well. Need to contact owner of crossing to determine status of crossing. (DWR UCIP - O. Magana) FIELD_STRUCT_DESC: 1 of 2: 4-inch galvanized iron sewage pipe sleeved through 6-inch steel pipe through the levee, 3.7 feet below the crown. Sump pump located on the waterside (WS) slope. Septic tank and observation well are located on the landside (LS). (4-inch pipe authorized under Permit No. 5427, 1966 - Patrick's Resort) [Additional Reference(s): DWR Levee Log, 1992. LMA encroachment station (STA) reference based on Map of Evacuation Route, Reclamation District 341 Sherman Island by Wagner Bonsignore Consulting Civil Engineers, A Corporation dated July 2012, STA 69+00] FS Date: 5/5/2009

LS view: sump pump inside drains to leach field.

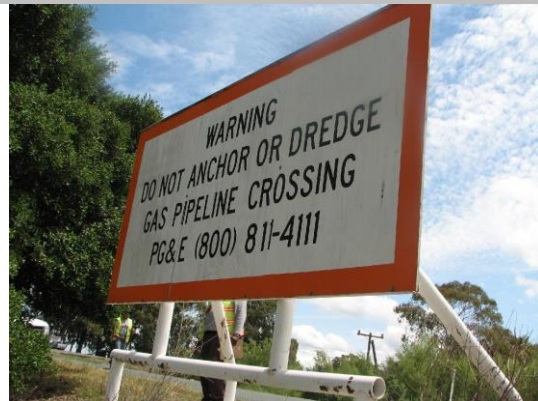
Photo 1 of 2 : UCIP_SP_2019_52261_37719.jpg

Comment Code					
Inspector Comment					
FS_ID:52261 DS_ID:24119 EP_NO: 960 Repair Type: Non-Urgent Crossing Status: Indicator Found UCIP Comments: 05/05/2009 Need to contact owner to determine last inspection and status of crossing. (DWR UCIP - O. Magana) FIELD_STRUCT_DESC: 1 of 2: 10-inch steel gas line through the levee, 2 feet below the levee crown. Cutoff wall around pipes located at the center of the levee. Valve pit located on the landside (LS) shoulder, with 2-inch drain pipe along LS slope. Location marker located on the waterside (WS) slope. Contact information for PG&E is 800-811-4111. (two 10-inch line authorized under Permit No. 960, 1944 - Pacific Gas and Electric Company [PG&E]; 10-inch pipes removed through levee-abandoned outside levee and replaced with unknown size pipes, and video inspection on gas line (G/L 169, G/L 302, G/L 131 (p. 24 of 30), and G/L 141 authorized under Permit No. 15319, 1990 - PG&E; line referenced by PG&E as G/L 131) [Additional Reference(s): DWR Levee Log, 1992. USACE Sacramento O&M Manual Unit No. 101, February 1962 (HLM 2.04). LMA encroachment station (STA) reference based on Map of Evacuation Route, Reclamation District 341 Sherman Island by Wagner Bonsignore Consulting Civil Engineers, A Corporation dated July 2012, STA 67+00] FS Date: 5/5/2009

Pipeline marker located on WS shoulder.

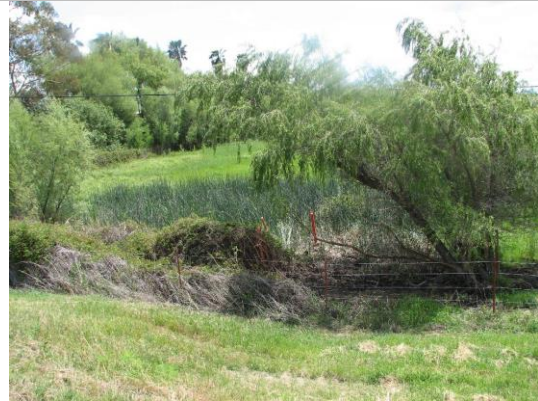
Photo 2 of 2 : UCIP_SP_2019_52261_37718.jpg

LS markers visible near levee toe.

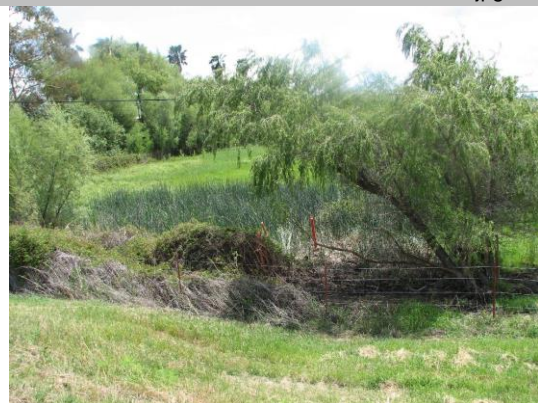
Photo 2 of 2 : UCIP_SP_2019_52262_37723.jpg

FS_ID:52262
DS_ID:24242
EP_NO: 960
Repair Type: Non-Urgent
Crossing Status: Indicator Found
UCIP Comments: 05/05/2009 Need to contact owner to determine last inspection and status of crossing. (DWR UCIP - O. Magana)
FIELD_STRUCT_DESC: 2 of 2: 10-inch steel gas line through the levee, 2 feet below the levee crown. Cutoff wall around pipes located at the center of the levee. Valve pit located on the landside (LS) shoulder, with 2-inch drain pipe along LS slope. Location marker located on the waterside (WS) slope. Contact information for PG&E is 800-811-4111. (two 10-inch line authorized under Permit No. 960, 1944 - Pacific Gas and Electric Company [PG&E]; 10-inch pipes removed through levee-abandoned outside levee and replaced with unknown size pipes, and video inspection on gas line (G/L) 169, G/L 302, G/L 131 (p. 24 of 30), and G/L 141 authorized under Permit No. 15319, 1990 - PG&E; line referenced by PG&E as G/L 131) [Additional Reference(s): DWR Levee Log, 1992. USACE Sacramento O&M Manual Unit No. 101, February 1962 (HLM 2.04). LMA encroachment station (STA) reference based on Map of Evacuation Route, Reclamation District 341 Sherman Island by Wagner Bonsignore Consulting Civil Engineers, A Corporation dated July 2012, STA 67+00]

Markers also visible on LS near levee toe.

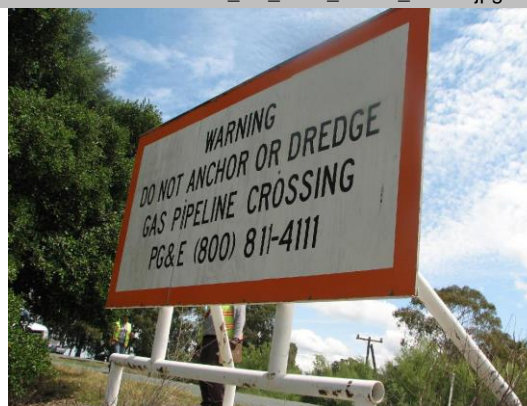
Photo 1 of 2 : UCIP_SP_2019_52263_71847.jpg

View of sign located on WS.

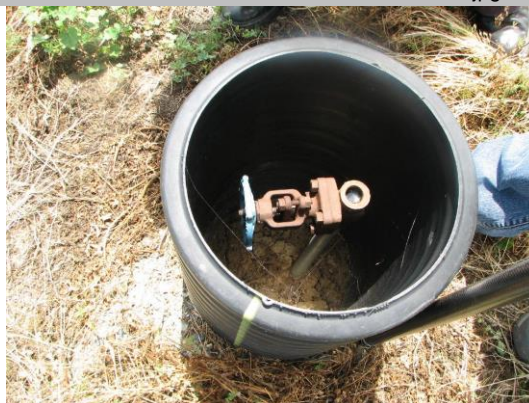
Photo 3 of 3 : UCIP_SP_2019_52264_37732.jpg

Primer stem located on LS slope.

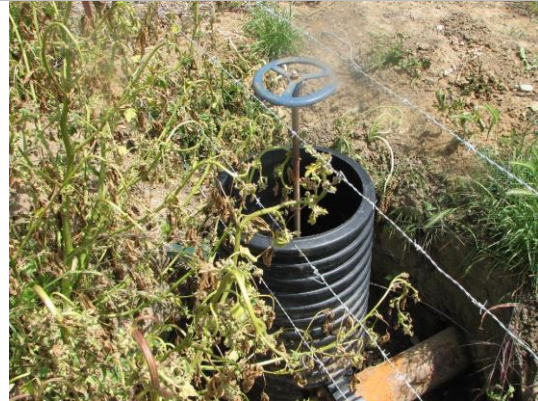
Photo 3 of 3 : UCIP_SP_2019_52265_37749.jpg

New distribution box and valve located on LS.

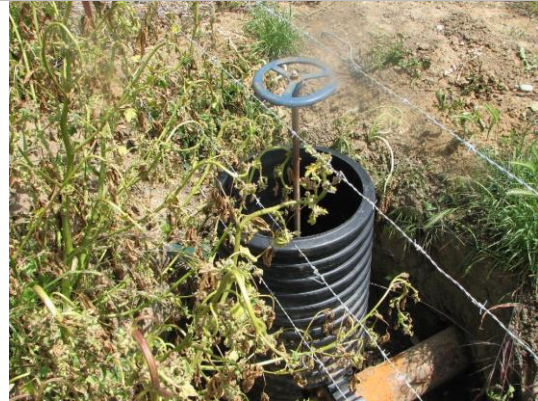
Photo 3 of 3 : UCIP_SP_2019_52266_37757.jpg

New distribution box and valve located on LS.

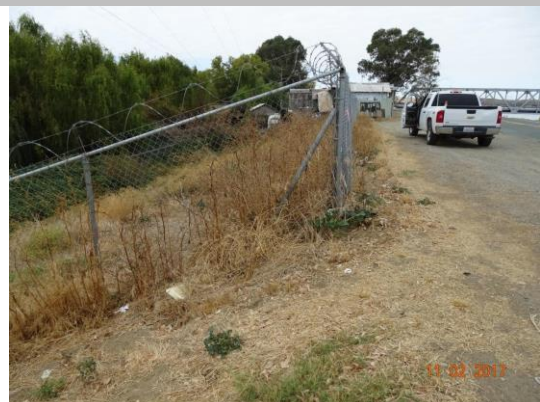
Photo 1 of 1 : SP_2019_RD0341_167_23_20190311_00004.jpg

View of unpermitted fence.

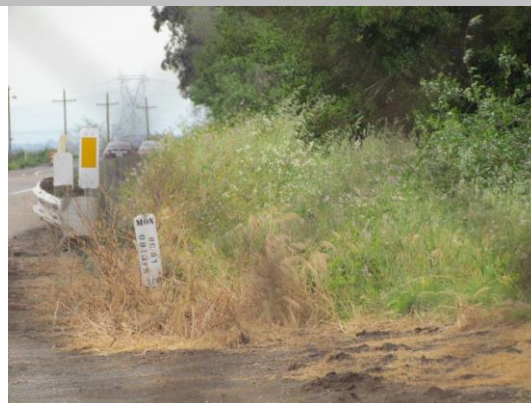
Photo 2 of 2 : SP_2019_RD0341_168_41_20190311_00006.jpg

Looking downstream from levee mile 3.94 at tall unwanted weeds and other vegetation on the waterside shoulder and slope.

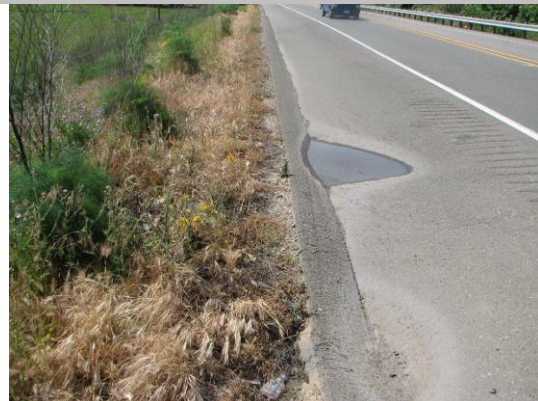
Photo 2 of 3 : UCIP_SP_2019_22203_37832.jpg

View of landward shoulder and low spots on highway.

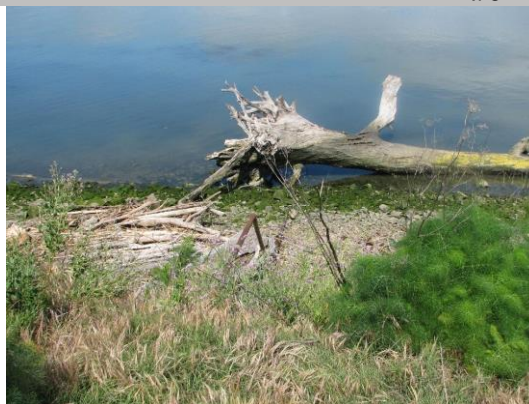
Photo 1 of 2 : UCIP_SP_2019_22186_37787.jpg

View of crossing on waterward side--dense vegetation on slopes.

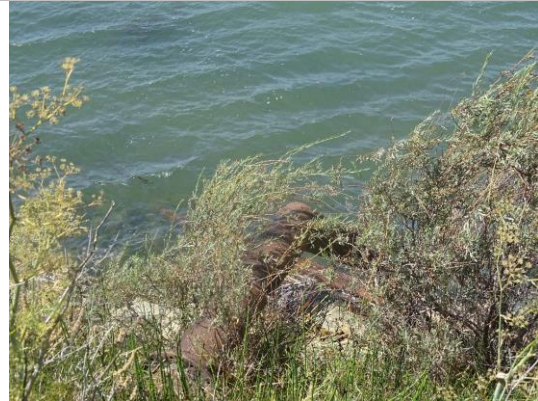
Photo 3 of 3 : UCIP_SP_2019_53343_77900.jpg

WS pipe; thick vegetation made access difficult.

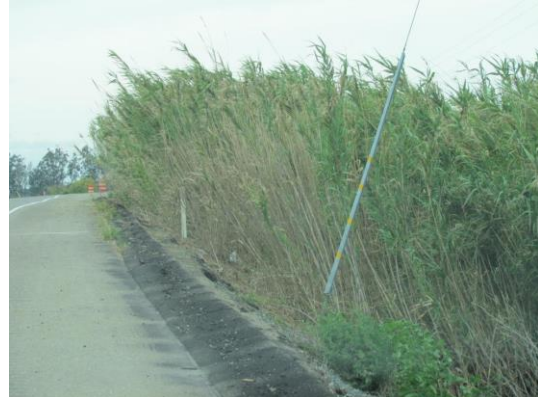
Photo 1 of 1 : SP_2019_RD0341_168_49_20190311_00015.jpg

RD 341 Landside slope from levee mile 6.03-6.10 tall unwanted growth of Arundo present on the levee section.
